New Hampshire Volunteer Lake Assessment Program

2003 Interim Report for Harrisville Pond Harrisville

Harrisville Pond, Harrisville

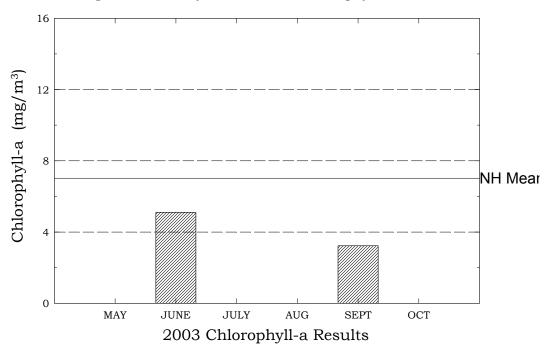
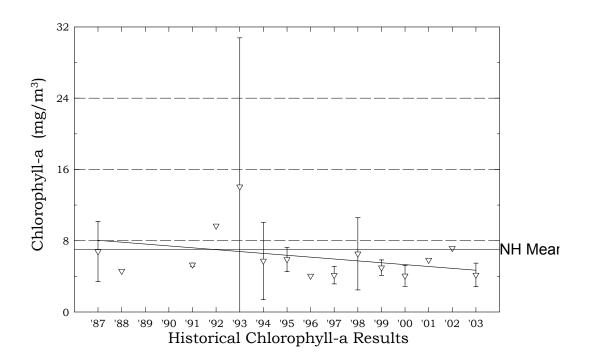
Figure 1. Monthly and Historical Chlorophyll-a Results

Figure 1 and Table 1: The graphs in Figure 1 (Appendix A) show the historical and current year chlorophyll-a concentration in the water column. Table 1 (Appendix B) lists the maximum, minimum, and mean concentration for each sampling season that the lake/pond has been monitored through the program.

The current year data (the top graph) show that the chlorophyll-a concentration *decreased* from June to September. The chlorophyll-a concentration on both sampling events was *less than* the state mean.

Overall, visual inspection of the historical data trend line (the bottom graph) shows a *variable* in-lake chlorophyll-a trend, meaning that the concentration has *fluctuated* since monitoring began in 1987. In the 2004 annual report, we will conduct a statistical analysis of the historical data to objectively determine if there has been a significant change in the annual mean chlorophyll-a concentration since monitoring began.

Chlorophyll-a, a pigment naturally found in plants, is an indicator of the algal abundance. Because algae are usually microscopic plants that contain chlorophyll-a, and are naturally found in lake ecosystems, the chlorophyll-a concentration measured in the water gives an estimation of the algal concentration or lake productivity. The mean (average) summer chlorophyll-a concentration for New Hampshire's lakes and ponds is 7.02 mg/m³.

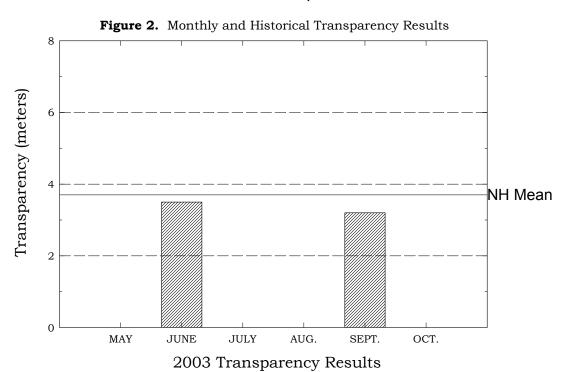
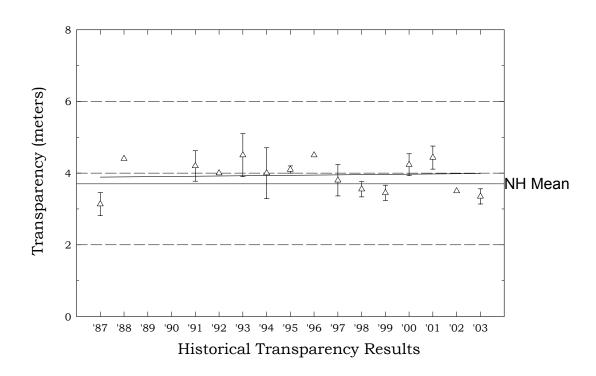
Figure 2 and Table 3: The graphs in Figure 2 (Appendix A) show historical and current year data for lake/pond transparency. Table 3 (Appendix B) lists the maximum, minimum and mean transparency data for each sampling season that the lake/pond has been monitored through the program.

The current year data (the top graph) show that the in-lake transparency **decreased slightly** from June to September. The transparency on both sampling events was **slightly less than** the state mean.

Overall, visual inspection of the historical data trend line (the bottom graph) shows a *relatively stable* trend for in-lake transparency. Specifically, the mean annual transparency has ranged between **approximately 3.5 and 4.5 meters** since monitoring began in 1987. As discussed previously, in the 2004 annual report, we will conduct a statistical analysis of the historical data to objectively determine if there has been a significant change in the annual mean transparency since monitoring began.

Volunteer monitors use the Secchi-disk, a 20 cm disk with alternating black and white quadrants, to measure water clarity (how far a person can see into the water). Transparency, a measure of water clarity, can be affected by the amount of algae and sediment from erosion, as well as the natural colors of the water. The mean (average) summer transparency for New Hampshire's lakes and ponds is 3.7 meters.

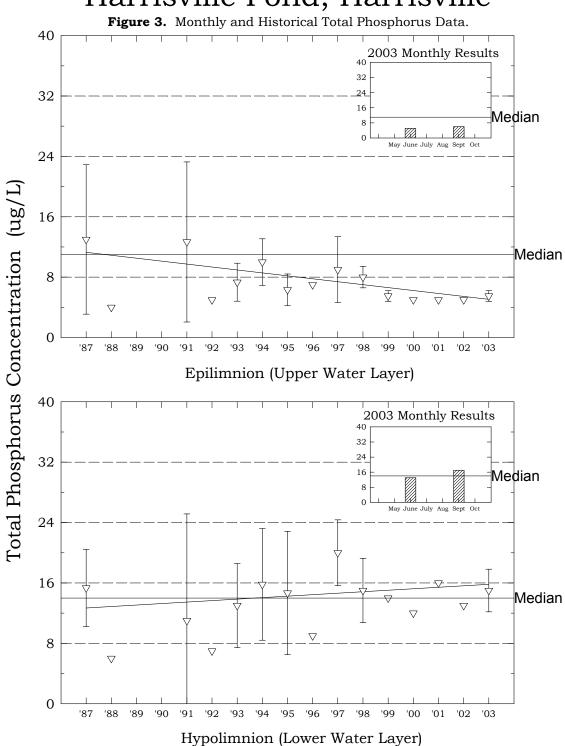
Figure 3 and Table 8: The graphs in Figure 3 (Appendix A) show the amounts of phosphorus in the epilimnion (the upper layer) and the hypolimnion (the lower layer); the inset graphs show current year data. Table 8 (Appendix B) lists the annual maximum, minimum, and median concentration for each deep spot layer and each tributary since the lake/pond has joined the program.

The current year data for the epilimnion (the top inset graph) show that the phosphorus concentration *increased very slightly* from June to September. The phosphorus concentration on both sampling events was *less than* the state median.

The current year data for the hypolimnion (the bottom inset graph) show that the phosphorus concentration *increased* from June to September. The phosphorus concentration in June was *less than* the state median, while the concentration in September was *greater than* the state median.

The historical data show that the 2003 mean hypolimnetic phosphorus concentration is **approximately equal to** the state median.

Overall, visual inspection of the historical data trend line for the epilimnion show **a slightly decreasing** phosphorus trend, which means that the concentration has **slightly improved** since monitoring began.

Overall, visual inspection of the historical data trend line for the hypolimnion shows **a stabilizing** phosphorus trend, which is **approximately equal** to the state median.

Phosphorus is the limiting nutrient for plant and algae growth in New Hampshire's freshwater lakes and ponds. Too much phosphorus in a lake/pond can lead to increases in plant and algal growth over time. The median summer total phosphorus concentration in the epilimnion (upper layer) of New Hampshire's lakes and ponds is 11 ug/L. The median summer phosphorus concentration in the hypolimnion (lower layer) is 14 ug/L.
